## Wall and Slopes Nº 457

# Slope Rehabilitation at Panhala Waghbil Road

📍 Panhala Fort, India

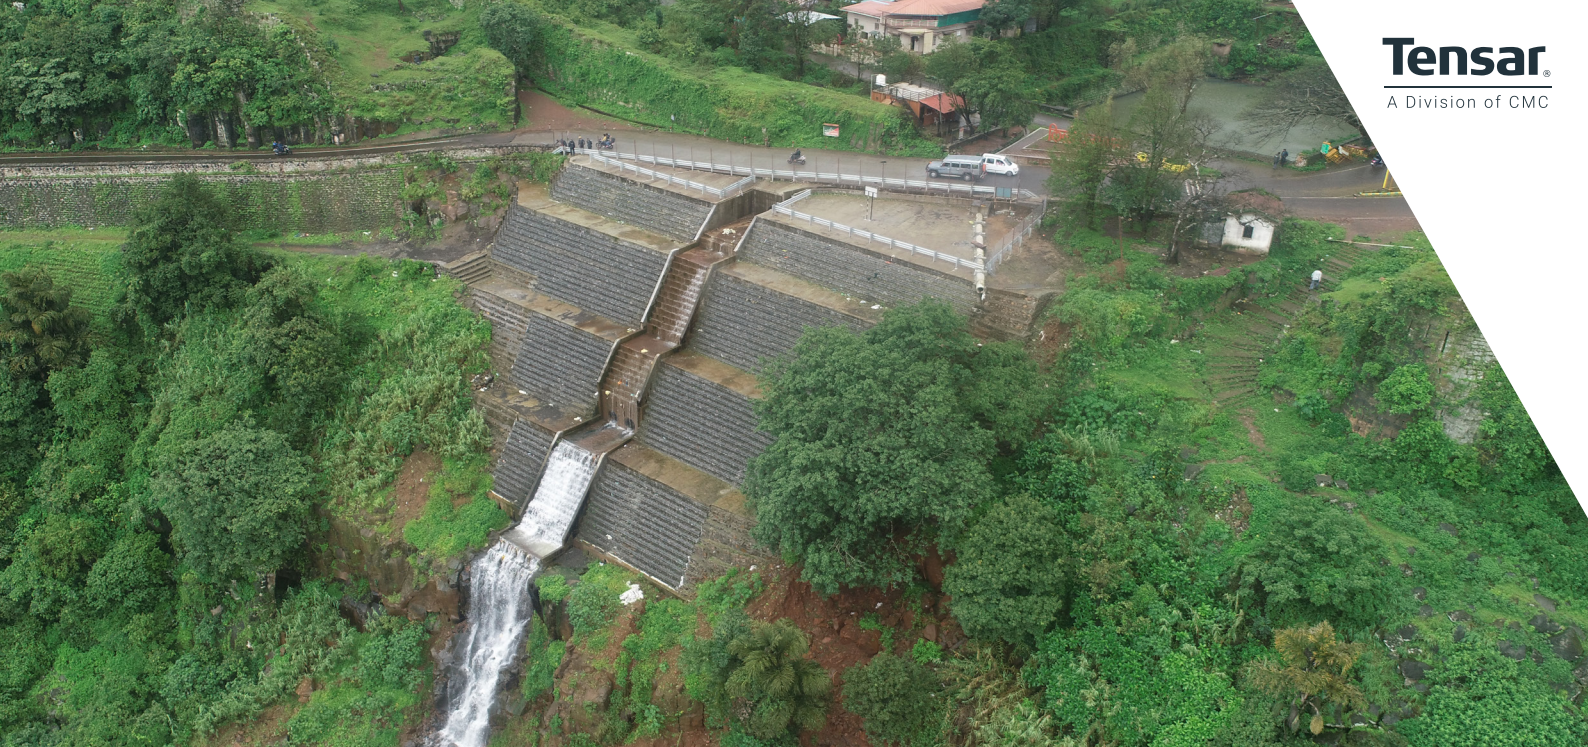
Tensar's Sierrascape system reconnects people quickly due to the project's short downtime, whilst being a cost effective and aesthetically pleasing solution.

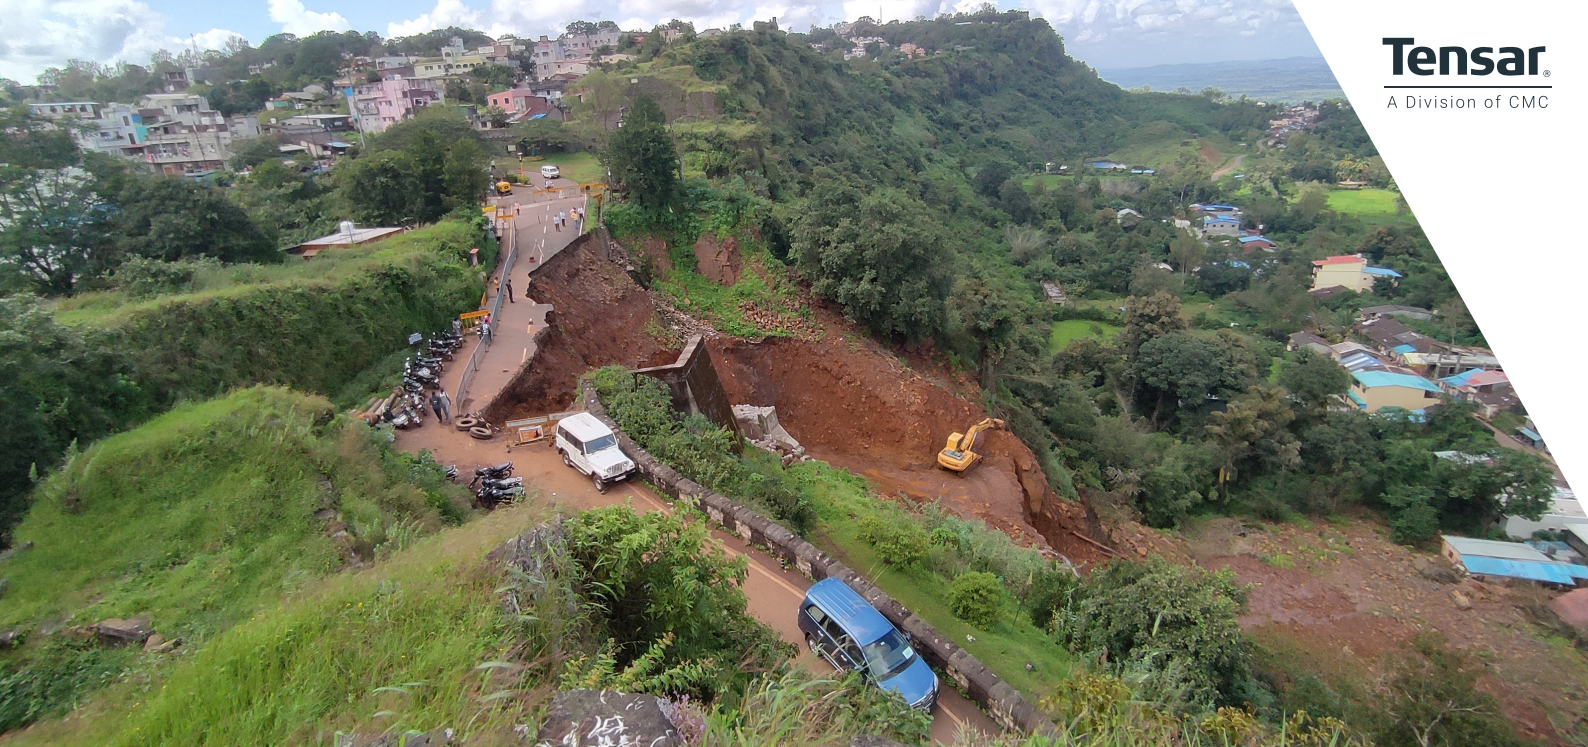
Slope failure cut off the only access to the historical fort and impaired the road which required rapid construction solution to reduce downtime

Panhala also known as “Panhalgad” is located in the Sahyadri mountain range, 20 km northwest of Kolhapur city in the state of Maharashtra, India. Panhala is a historical fort and an important tourist attraction in the Kolhapur district. In July 2021, Panhala and the surrounding region was subjected to heavy downpour for several days which caused a huge inflow of runoff. There were three sluice outlets coming out of the Sadoba lake located on the hilltop which discharged the water in the valley passing through the slope body. The insufficient or choked drainage systems had caused the inflow to saturate the slope fill. The primary reason for the road slope failure was attributed to the ingress of rainwater and insufficient drainage arrangement. Public Works Department’s officials approached Tensor for an economical and proven solution for the rehabilitation works.

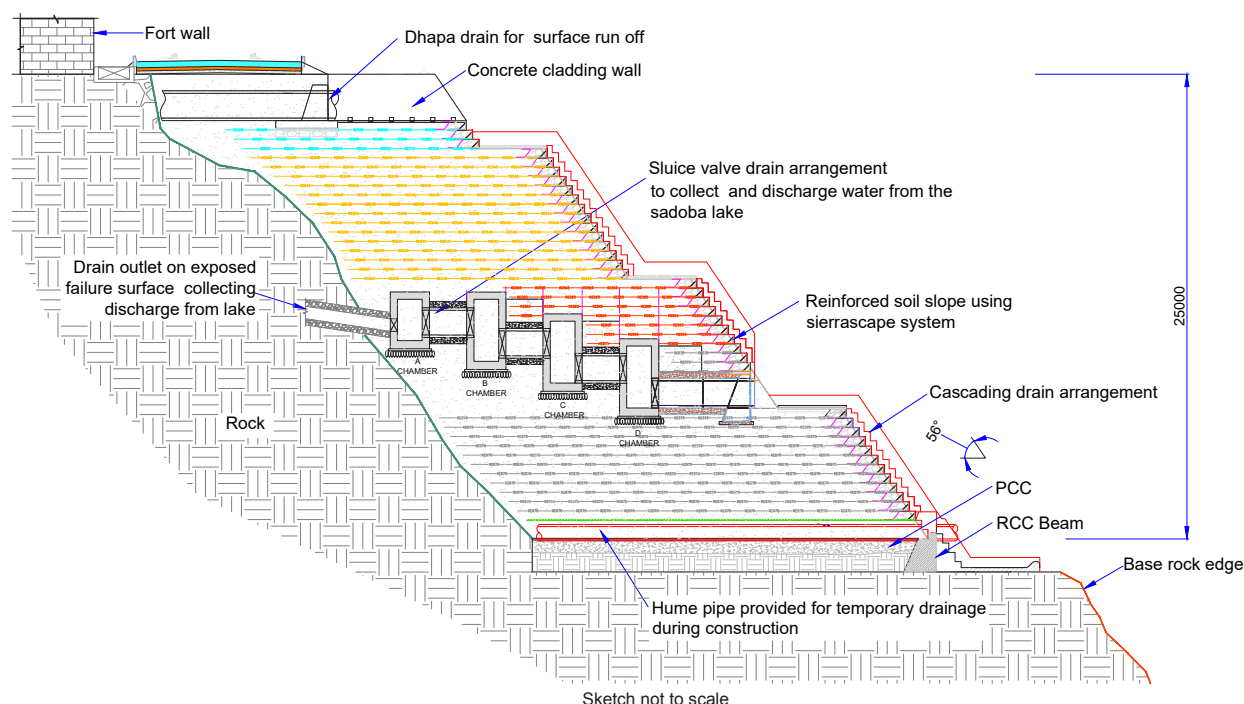
## REINFORCED SOIL STRUCTURE’S CROSS SECTION

A multi-tiered reinforced soil slope featuring the SierraScape system was proposed by Tensar and it represented an excellent solution from a technical, economical and construction standpoint. The lower cost and rapid construction of the SierraScape system, along with the simple construction approach provided significant cost savings when compared to tradition forms of construction.
