# Rehabilitation of a boundary wall using Gabion Faced Retaining Wall System

## Rehabilitation of a boundary wall at Nilkamal production plant

Tamil Nadu, India

Walls and Slopes | No. 536

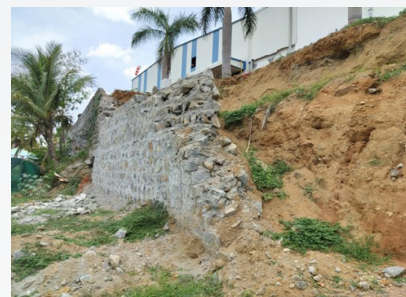
*Image of the UCR Wall that has collapsed due to rain.*

The Southern section of the UCR masonry wall surrounding the Nilkamal production plant in Shoolagiri, near Hosur, Tamil Nadu, suffered a collapse, leaving the backfill vulnerable to erosion and sliding. Investigation revealed that during the heavy monsoon rains in 2022, water had deeply percolated into the foundation, eroding the supporting soil due to inadequate drainage arrangements.

This erosion compromised the foundation's stability, leading to the wall's failure. The section has a previous recurring history of collapse which has led to serious disputes with neighbouring farmers due to debris falling onto their farmland. Hence, the situation demanded a permanent, cost-effective solution that could be implemented promptly using available resources. Tensar proposed a geogrid reinforced soil wall using uniaxial geogrid with gabion fascia as the solution.

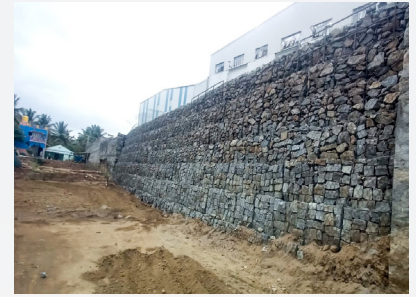
*The completed gabion fascia TensarTech® Rock Wall.*

Tensar proposed a geogrid reinforced soil wall using uniaxial geogrids with gabion fascia—a proven, economical alternative to conventional reinforced cement concrete (RCC) walls. The complete solution included design, drawings, and on-site supervision, ensuring quality construction appropriate drainage measures. Tensar solution allowed the reuse of salvaged rocks from the failed wall, reduced costs, construction time, and enhanced sustainability.

The gabion fascia system is well-regarded in the region for its proven performance, cost-effectiveness, and aesthetic appeal. Unlike a reinforced cement concrete wall, it eliminated the need for expensive temporary shoring and lengthy construction timelines.
